# CMS Phase I Pixel Module Qualification

John Stupak III

University of Oklahoma

12/12/16

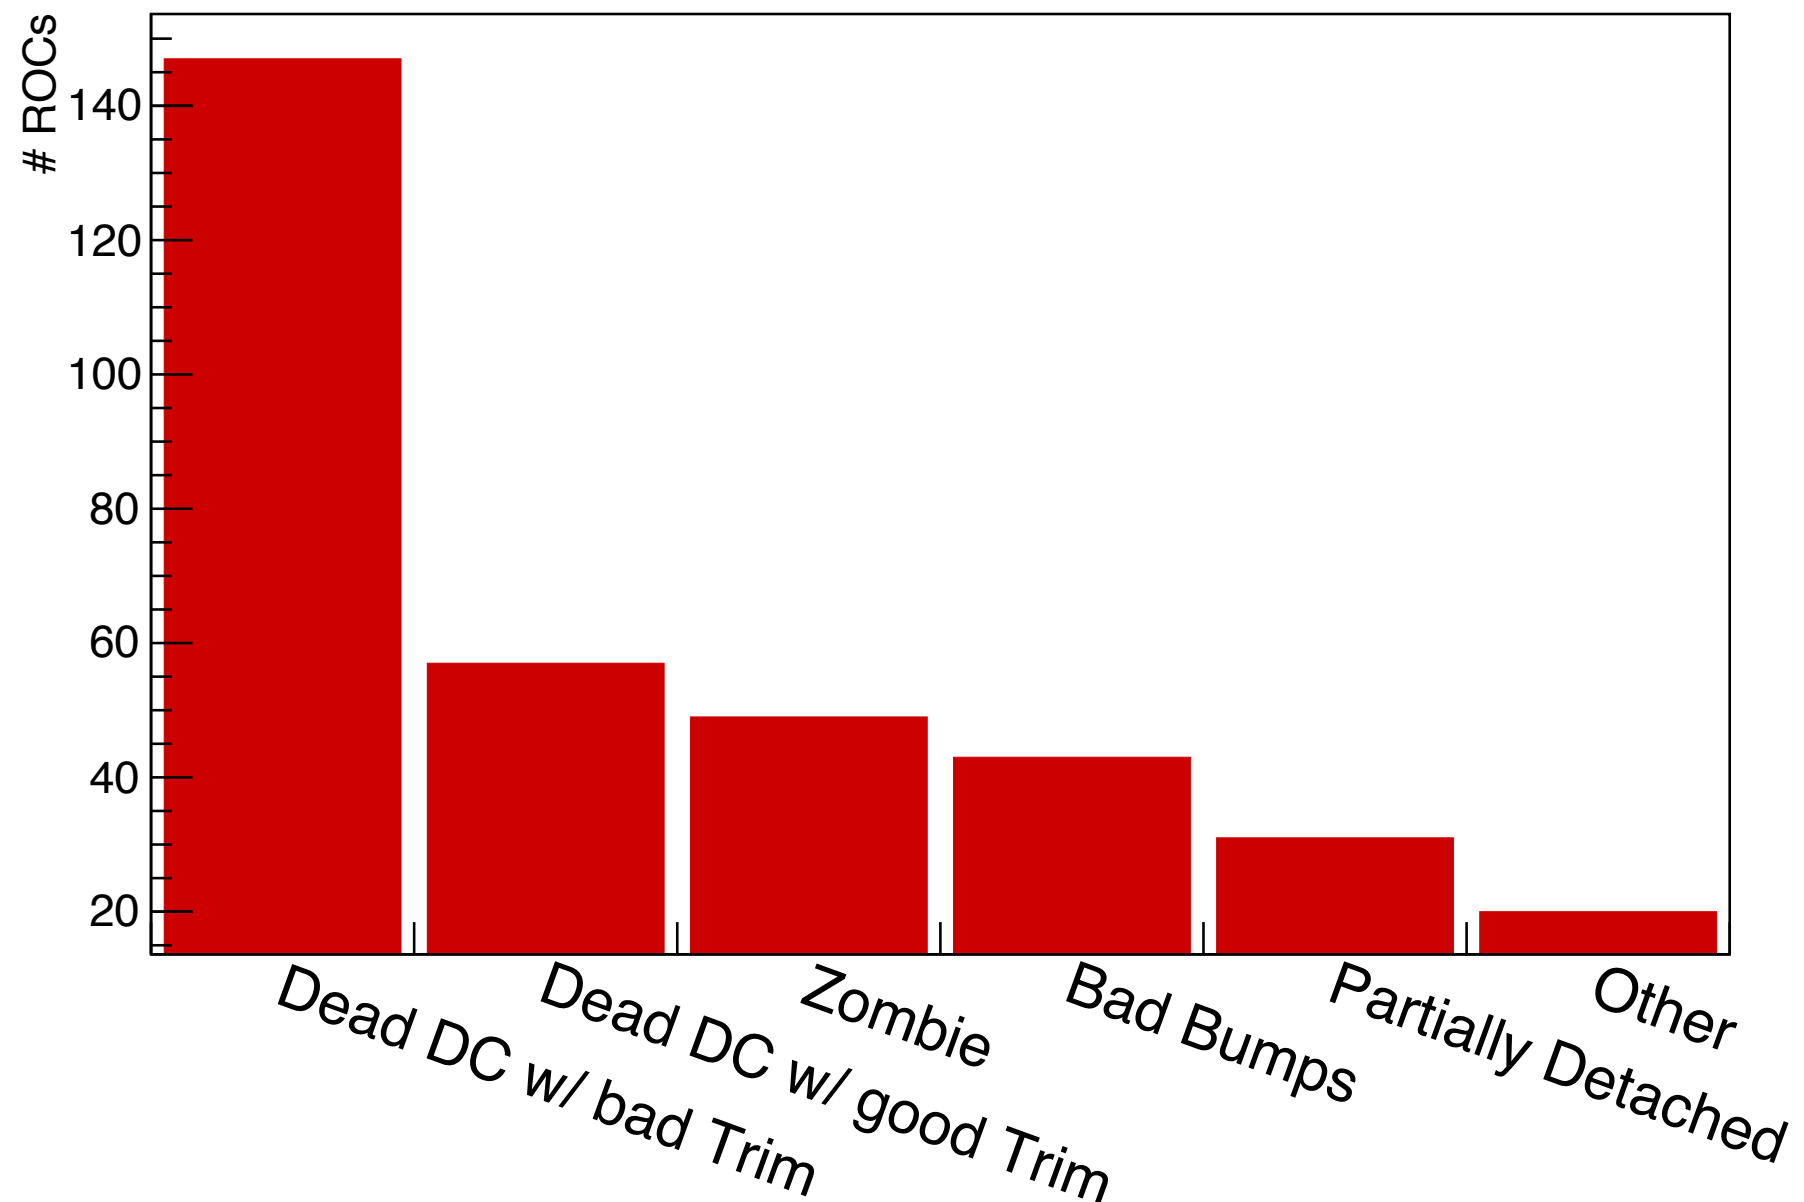
ROC Failure Mode Frequencies (570 modules)

TBM failures (replace TBM and retest)  
Sensor failures (IV: very few failures)  
ROC failures dominate (see plot)

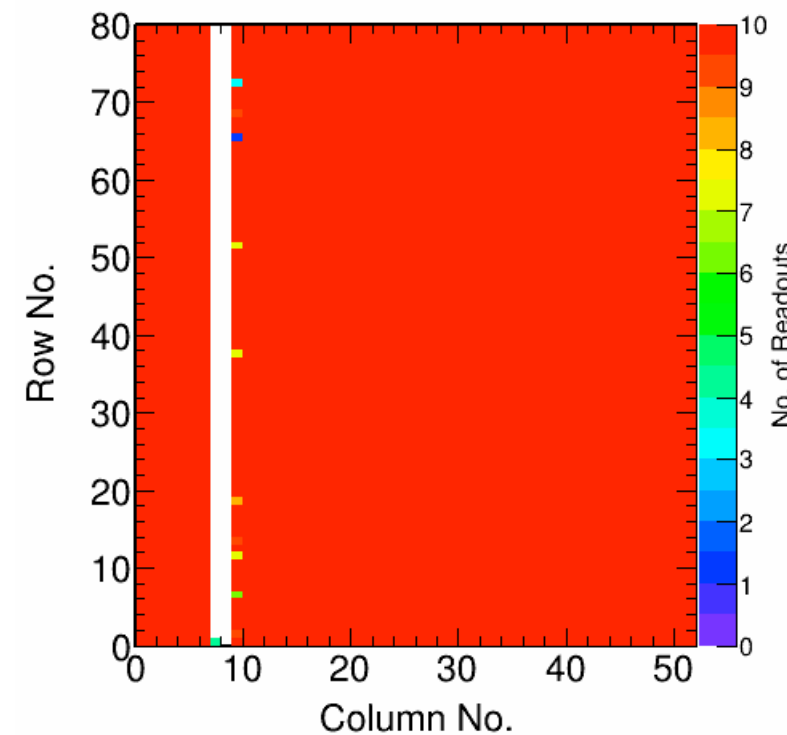
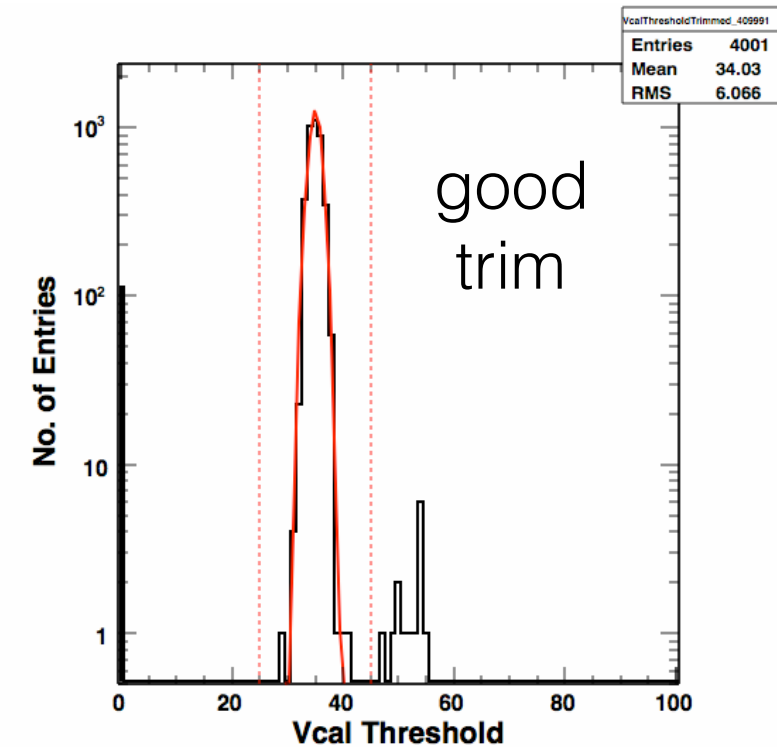
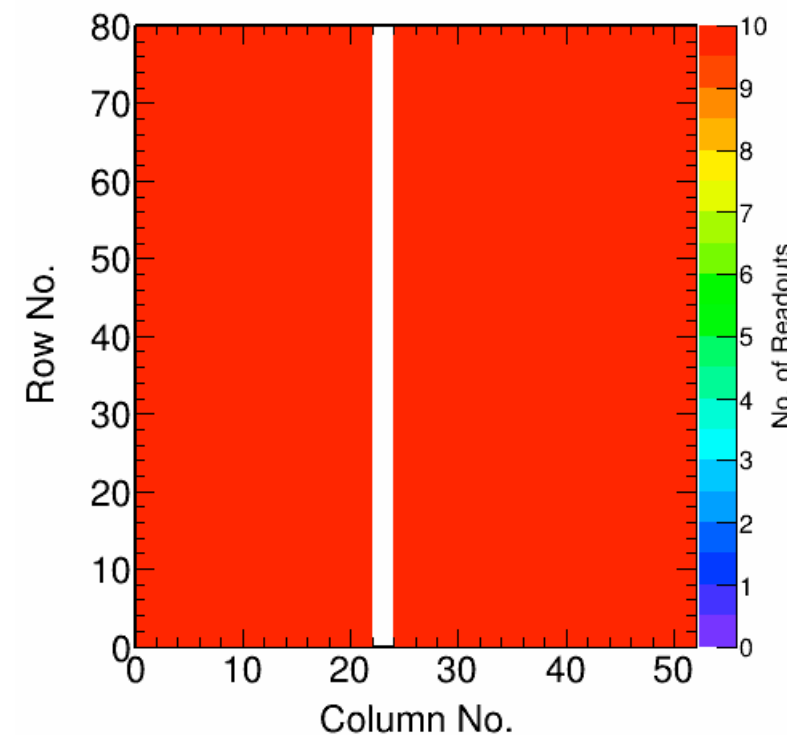
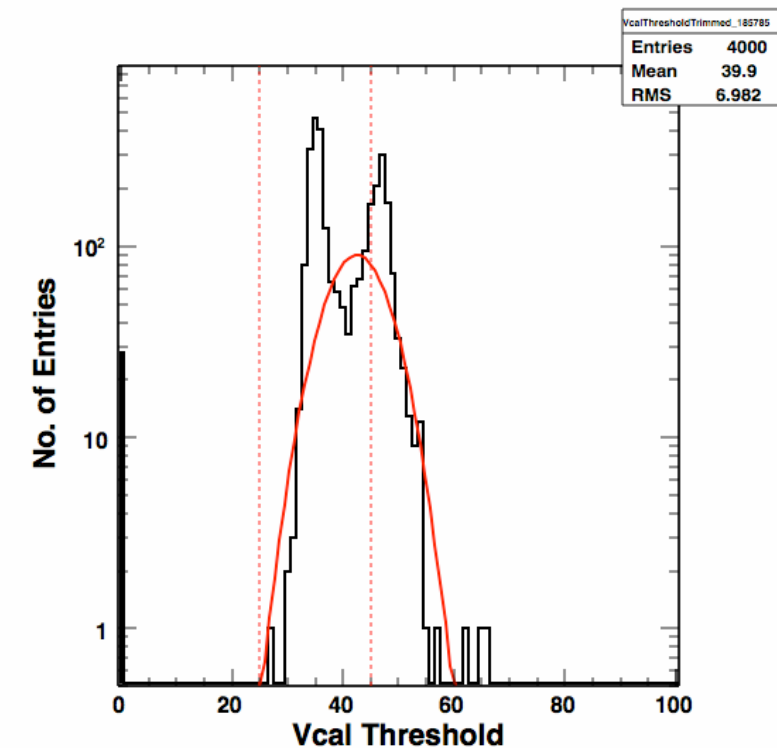
# Failure Mode: Dead double columns & zombie ROCs

Dominant failure modes so far in production

Readout is done via a double column drain mechanism, so this means one readout circuit is dead

Dead DC can draw more current so that rest of ROC is underpowered

In this case, often pixels can't fire at the low thresholds required for trimming

“Zombie” ROCs give no data but don't affect module data stream

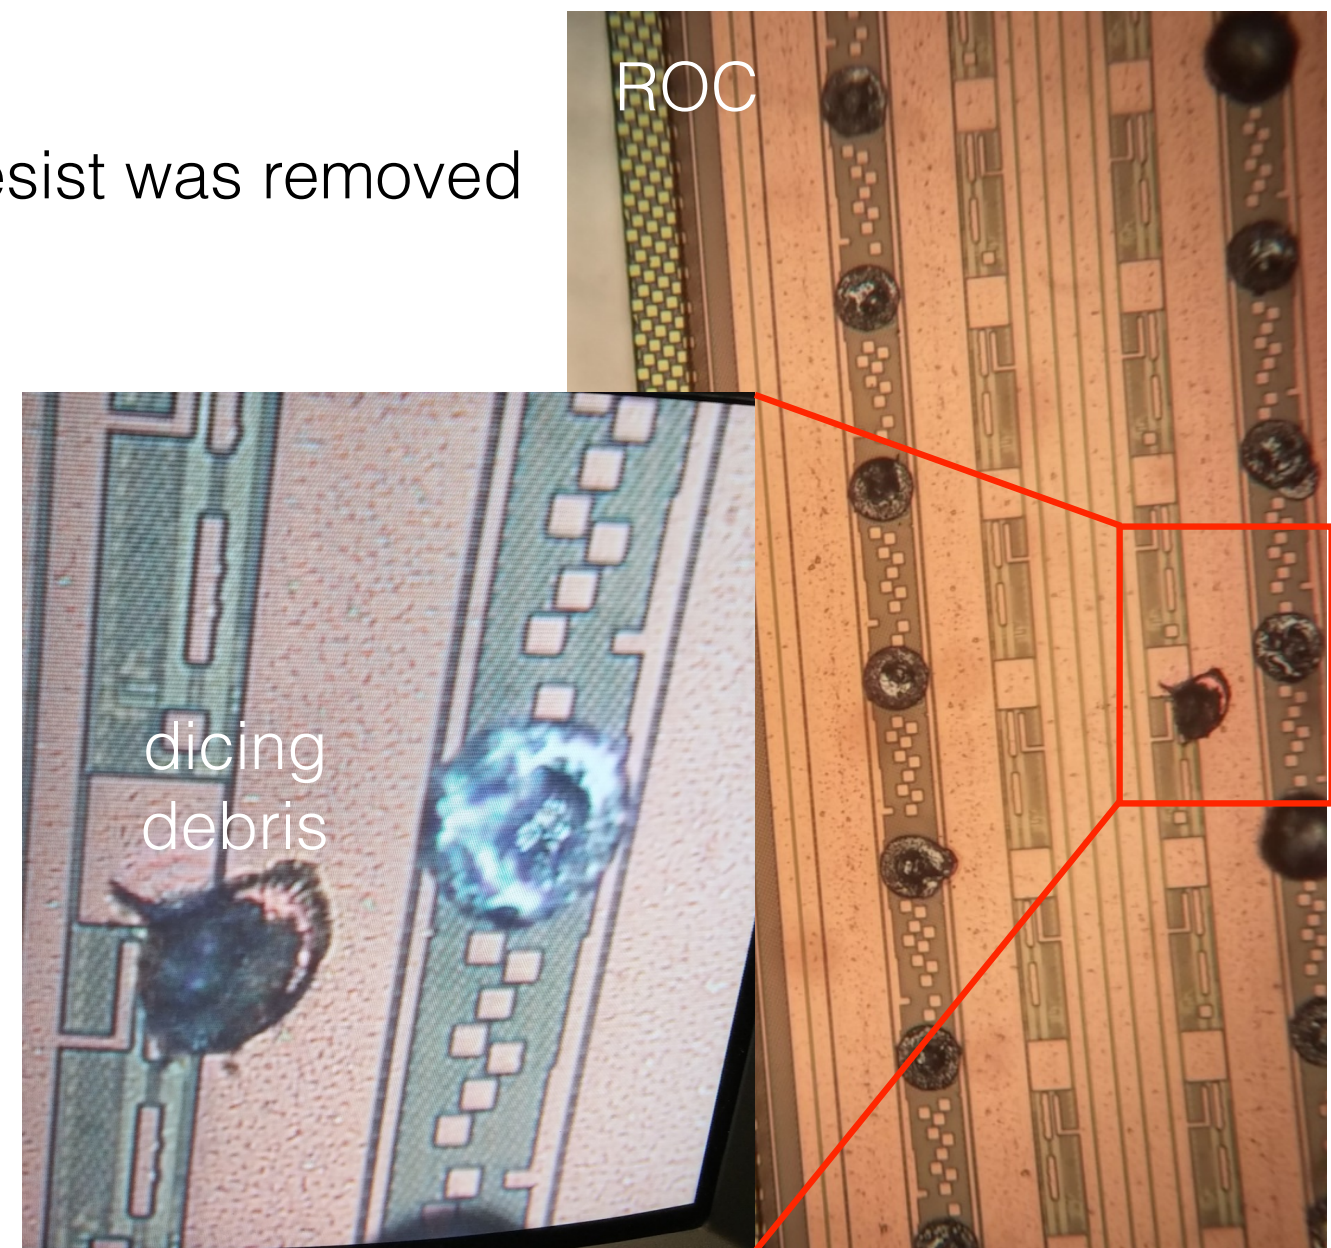
# Cause: Dicing debris

Once bump bonds are deposited on ROC wafers, the wafers are diced into individual ROCs with a saw

During pre-production, a layer of photoresist was still present on the ROC surface during dicing, being removed later

To save time during production, the photoresist was removed before wafer dicing

This often caused silicon debris from the dicing saw to get lodged on the ROC surface

If debris is present in the active area of the ROC, it causes a double column failure

If debris is present in the periphery, the entire ROC can be affected

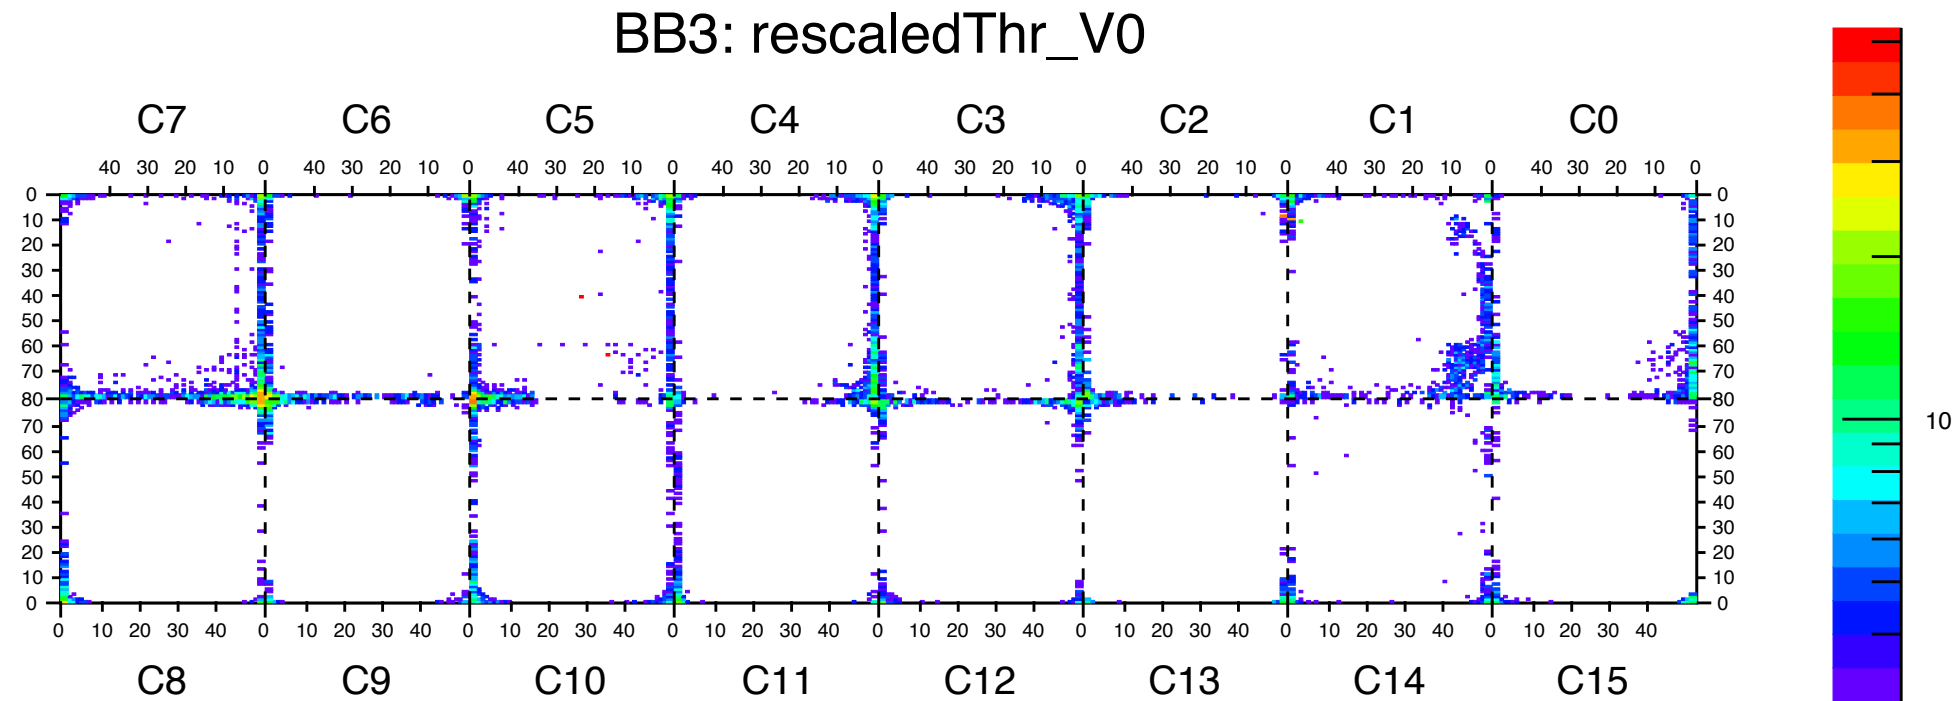
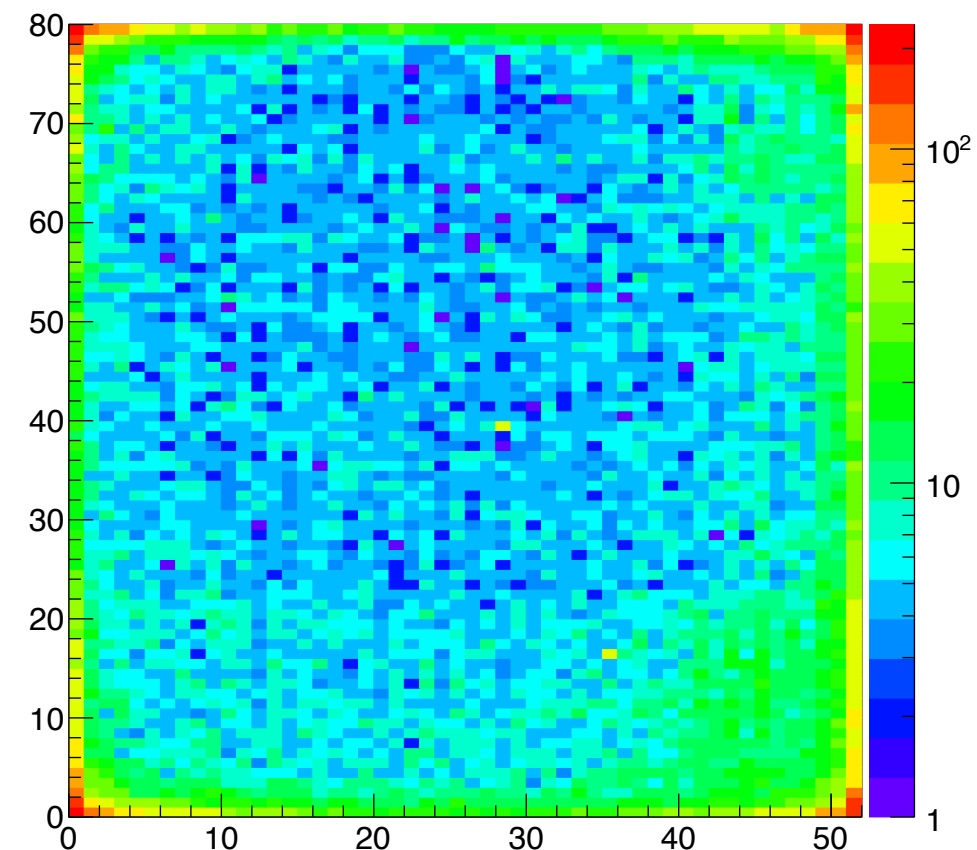
# Failure Mode: Damaged bump bonds

ROC Summary of Bad Bumps using 7094 ROCs

plots show the sum of bad bumps in otherwise good ROCs for ~450 modules

~0.1% of bump bonds are damaged during production/testing

damage is generally from mechanical stress and thus concentrates around the edges of the ROC

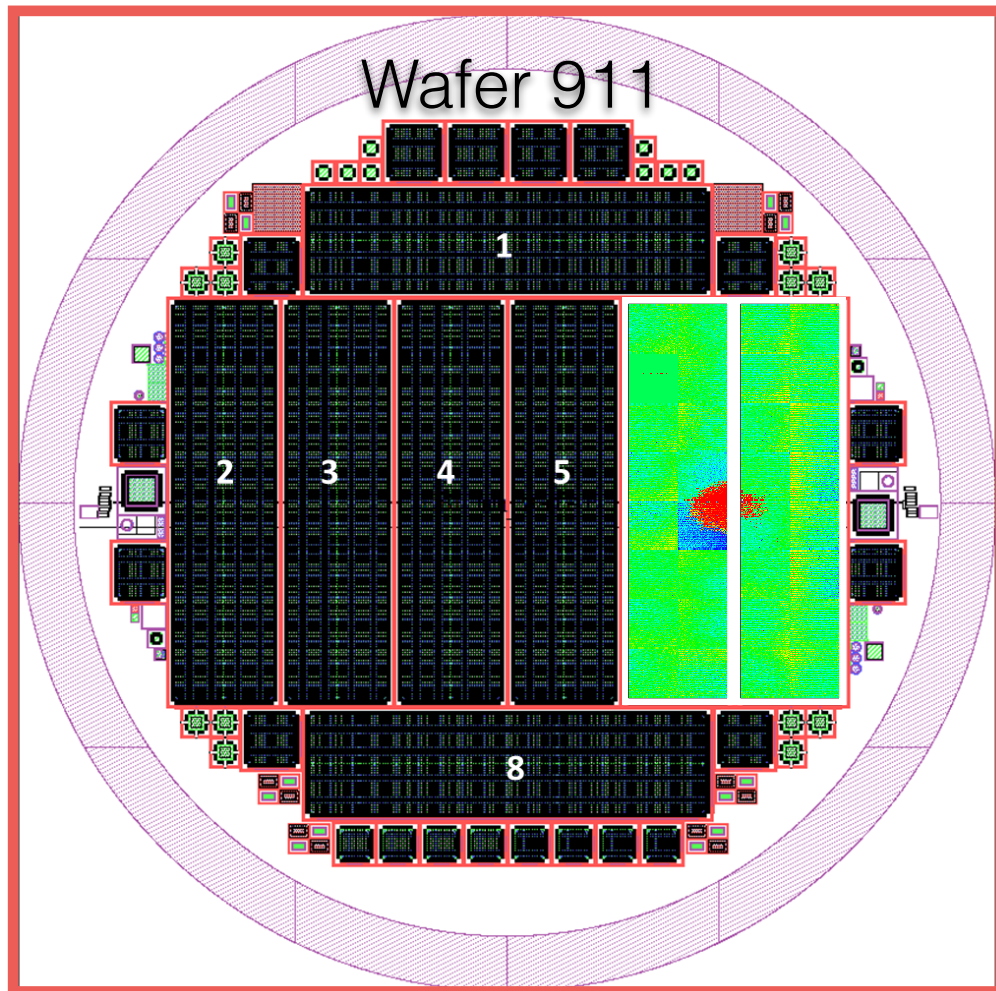
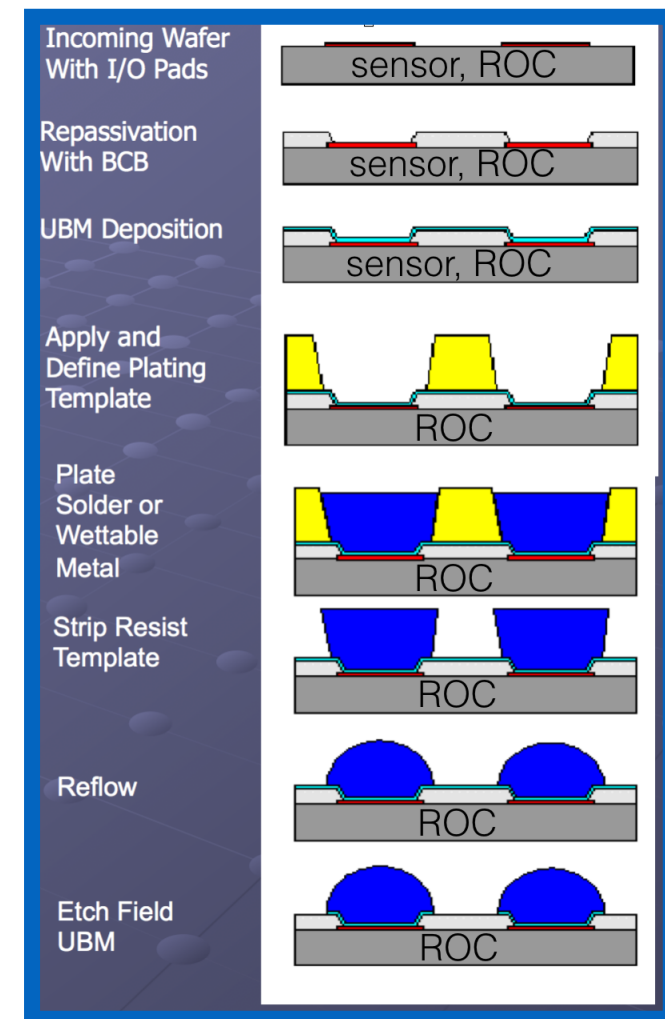
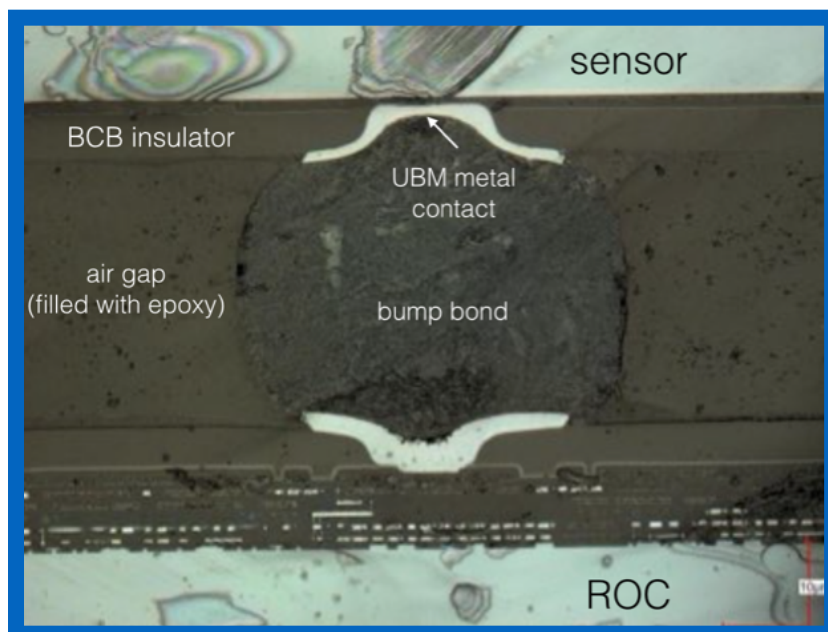
# Preproduction “Fingerprint” Issue

pattern correlated over multiple sensors on the original silicon wafer

inefficiency in plasma etching of BCB insulating layer between bump bond and sensor surface

**We used variety of tools and expertise, in collaboration with the vendor, to rectify a problem that could have slowed production**

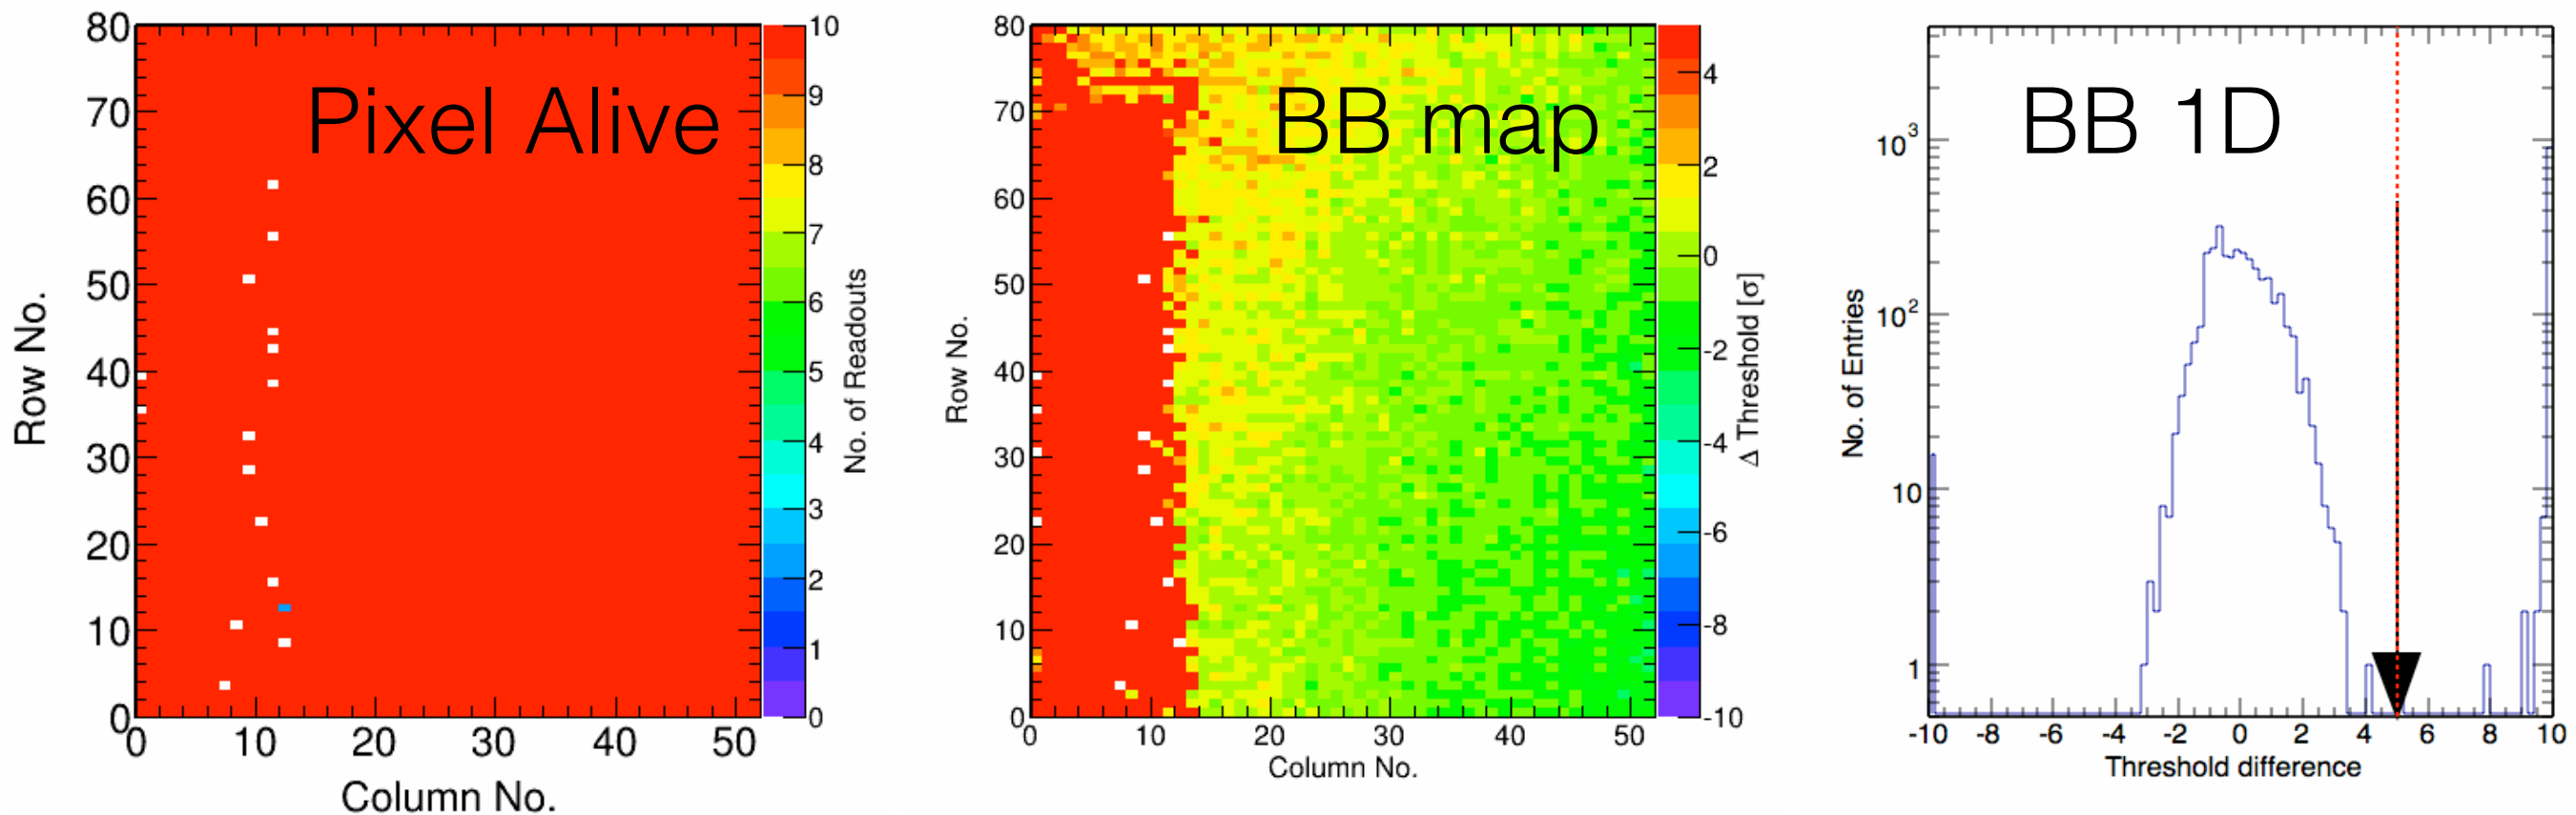
# Partially detached ROCs

Pattern of dead pixels along a border of regions of working and non-working bump bonds

Working/non-working bumps are well separated in BB discriminant

Size of region of bad bumps varies greatly from module to module

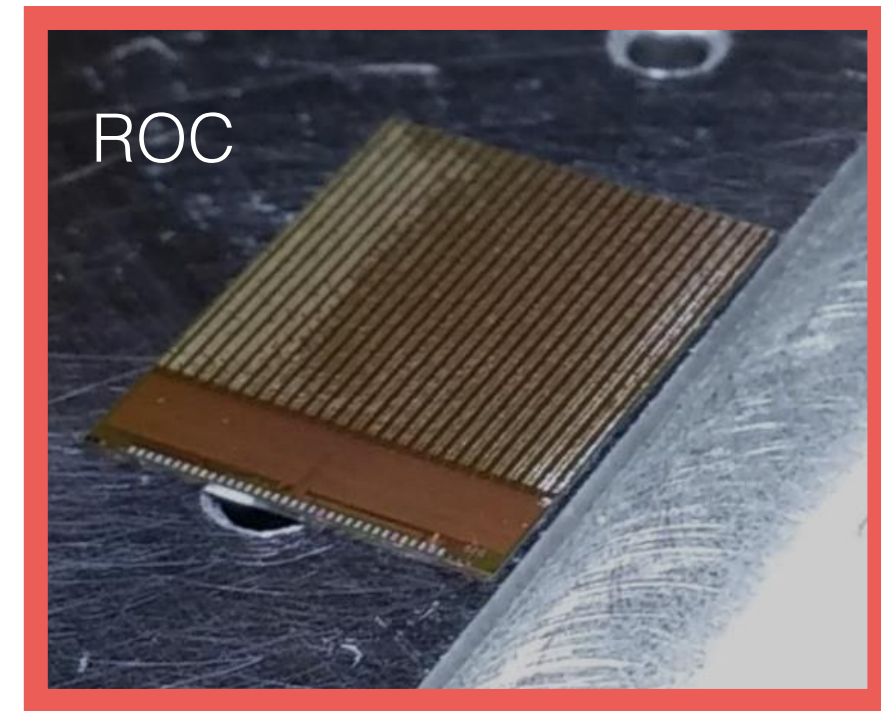
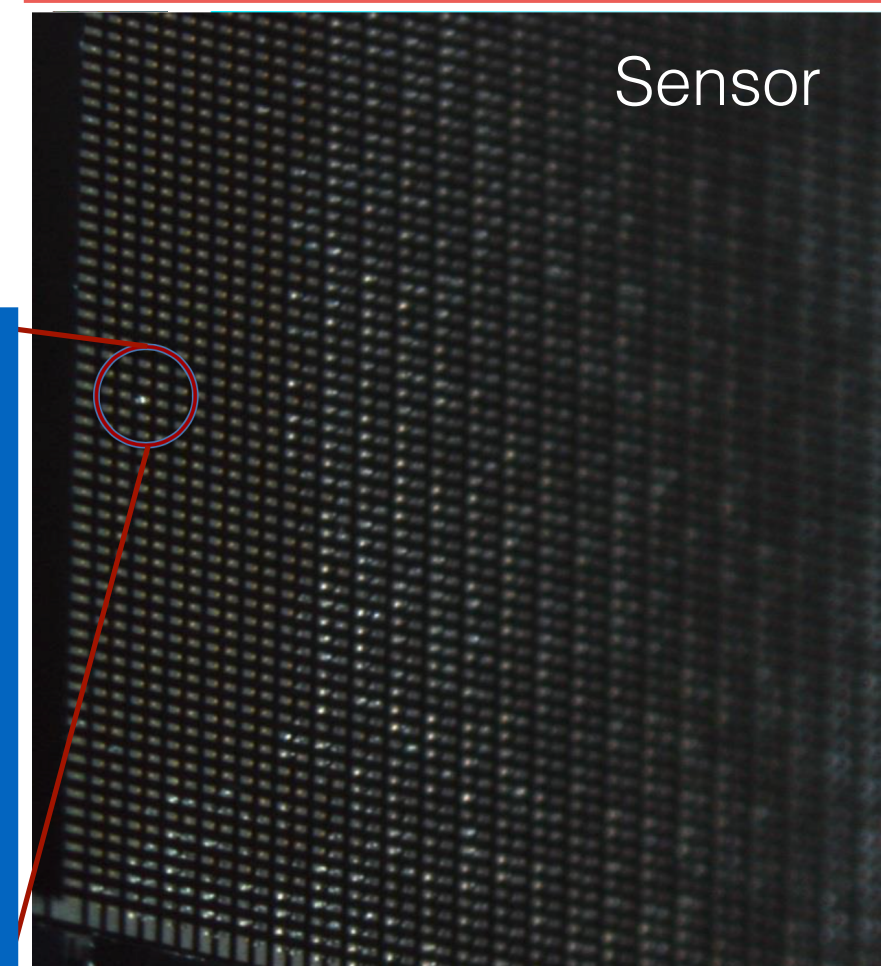
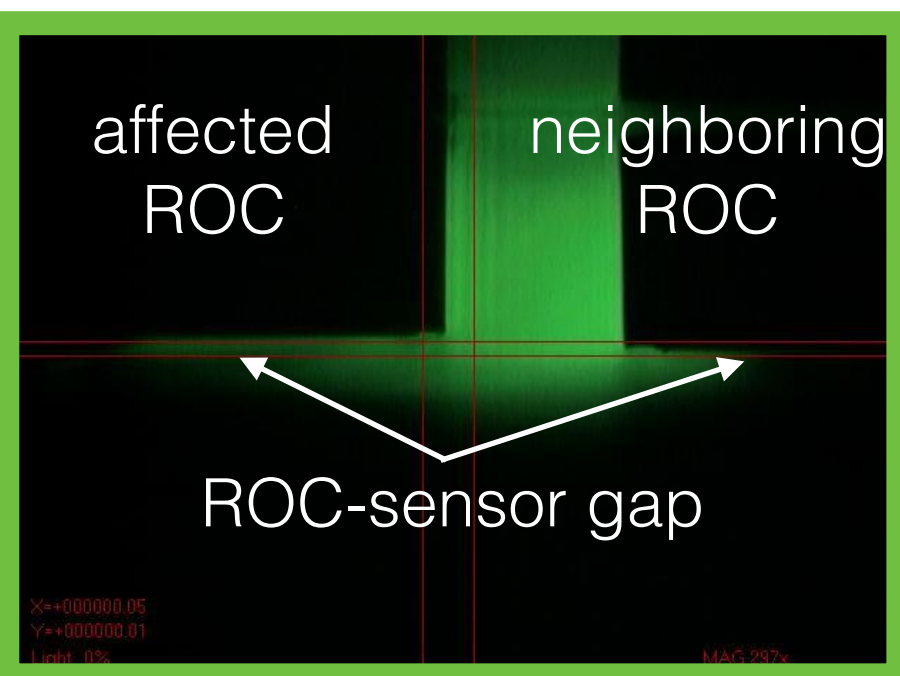
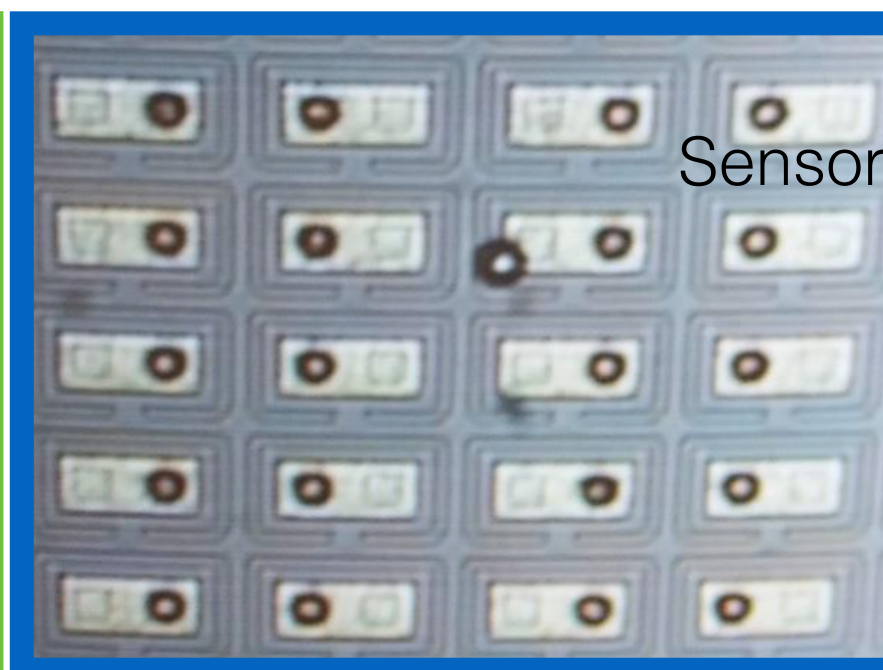
# Cause: Misplaced bump bond

ROC from previous slide was removed from module

A single misplaced bump bond was observed

Misplaced bump acts as a wedge between sensor and ROC during bump-bonding

An additional  $\sim 10\text{ }\mu\text{m}$  gap was observed between ROC and sensor in one such module
